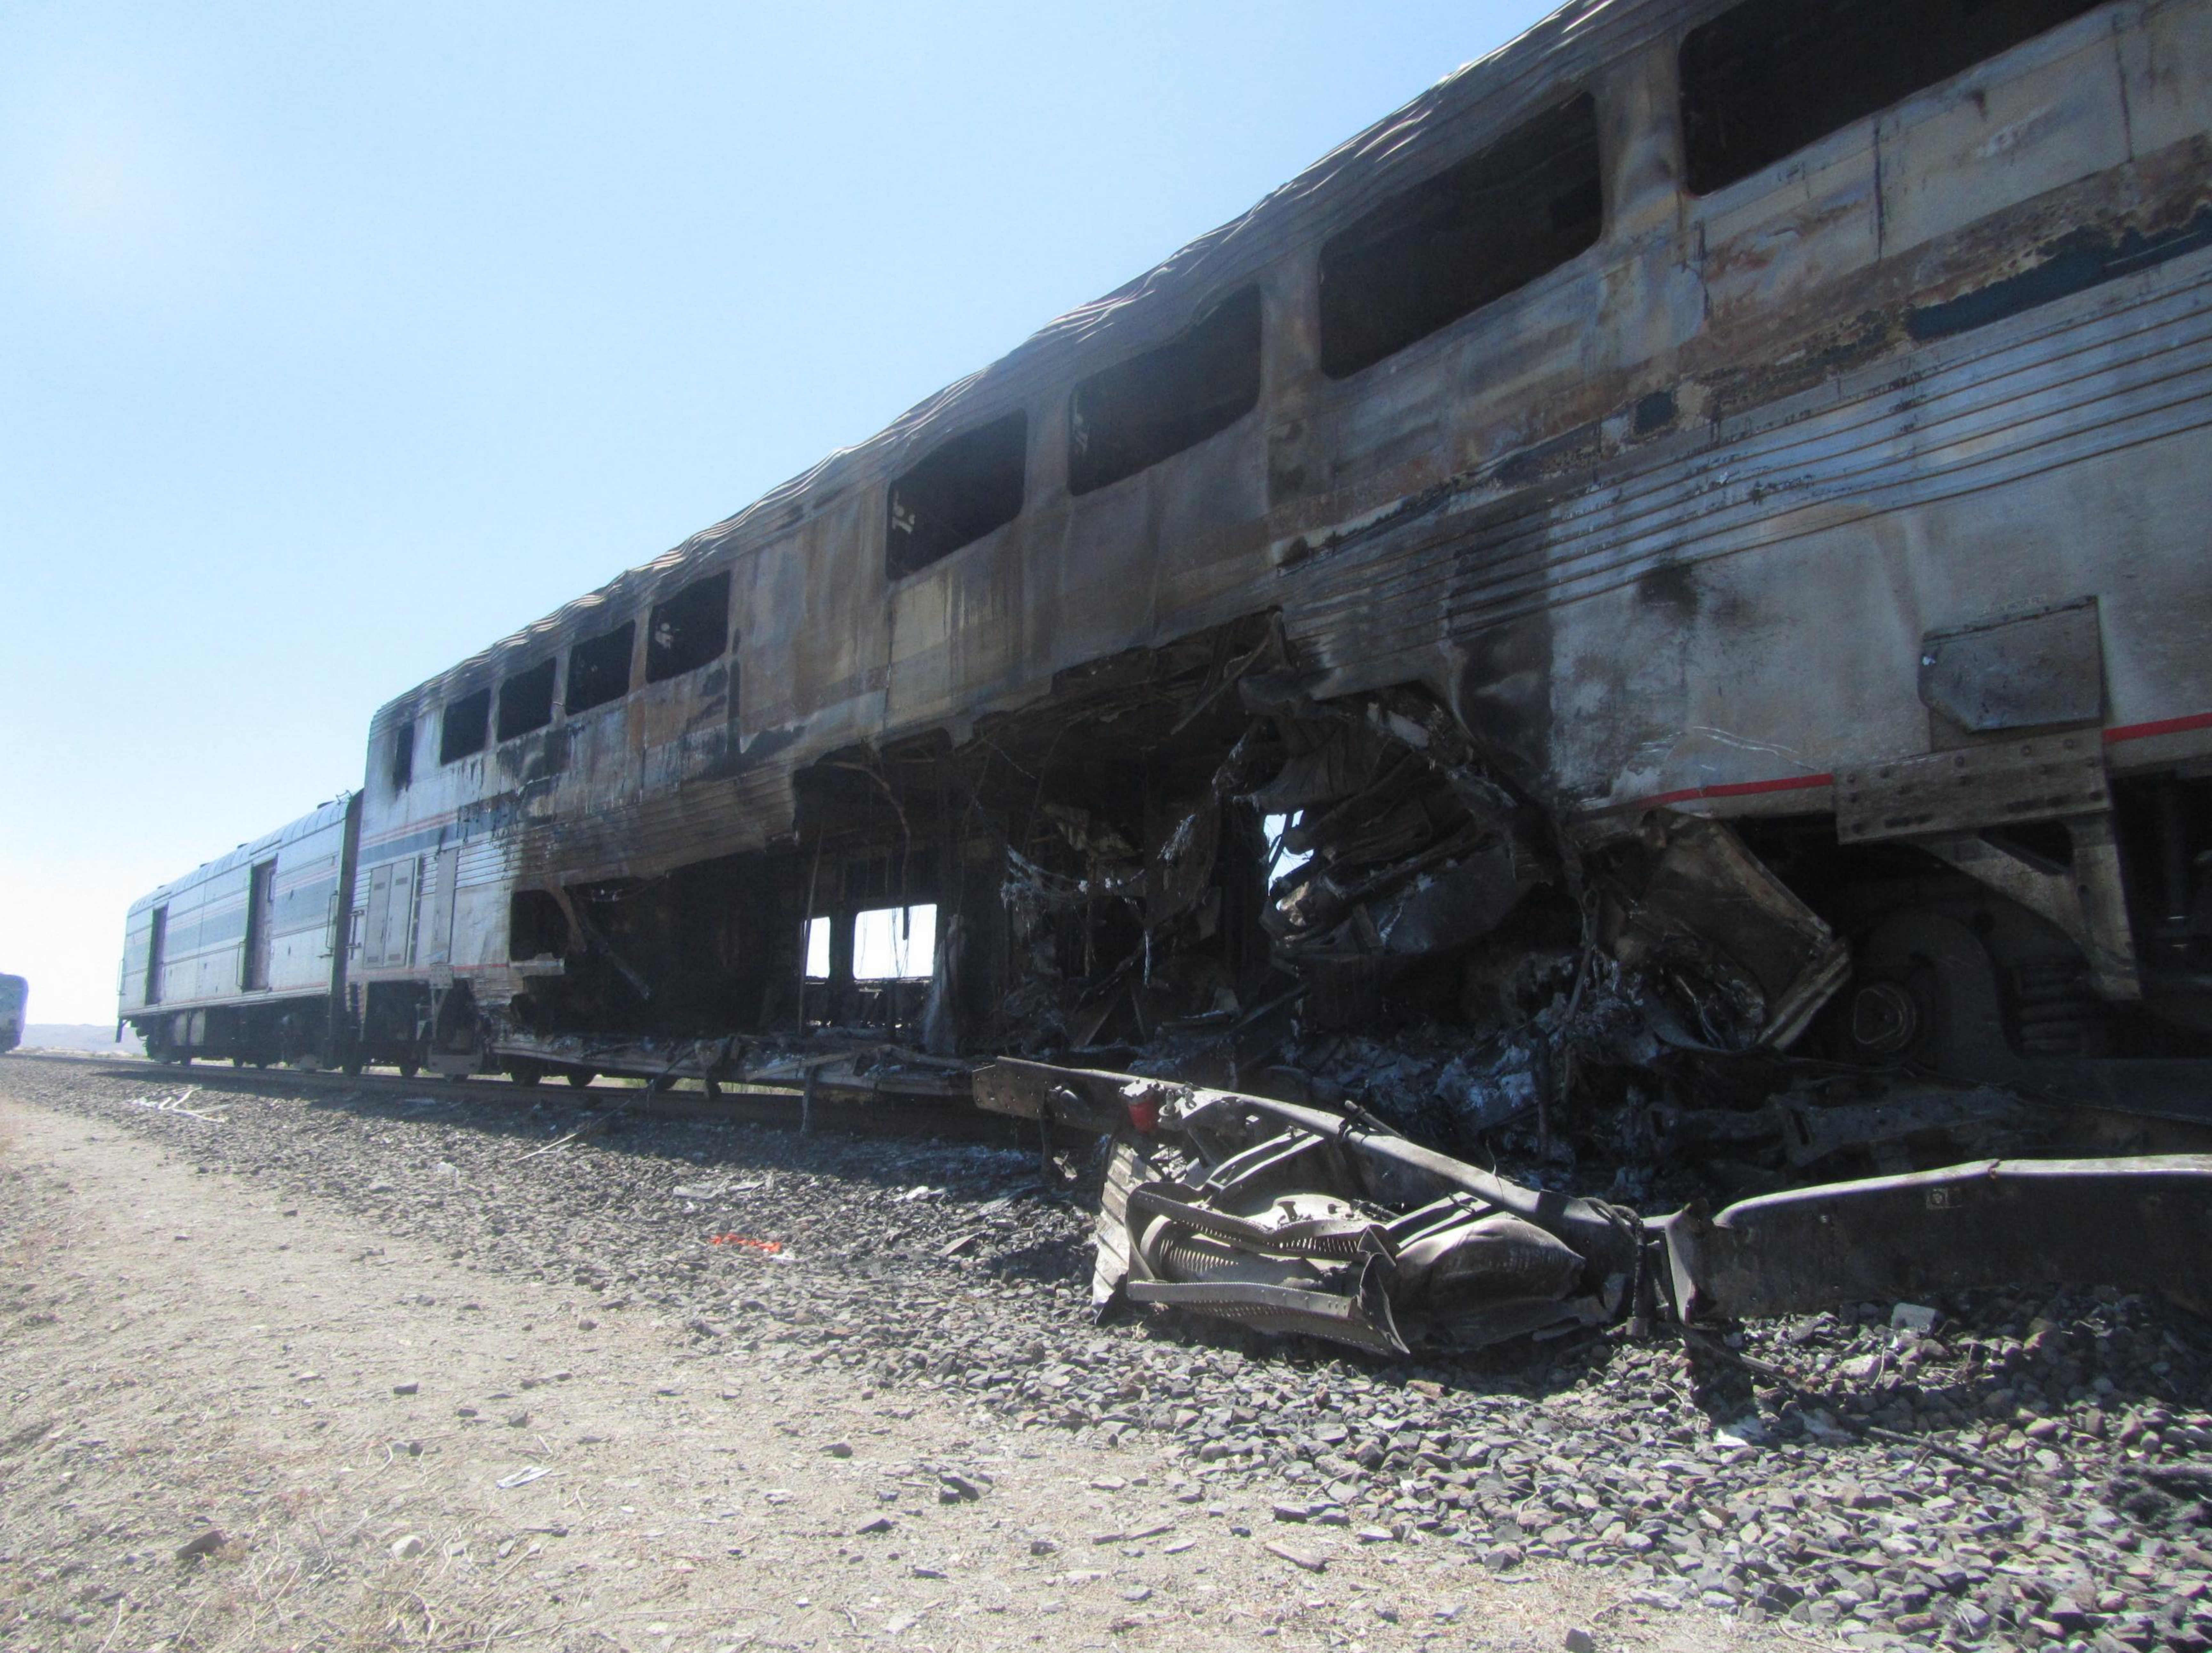
Figure 2. View of impact damage and fire damage to the Amtrak crew car.
